## Coal Mine Fatal Accident 2006-25

Operator:	Tri Star Coal L.L.C.
Mine:	No. 1
Accident Date:	April 20, 2006
Classification:	Fall of Roof
Location:	Dist. 6, Pike County, Kentucky
Mine Type:	Underground Coal Mine
Employment:	9
Production:	1,000 Tons/Day

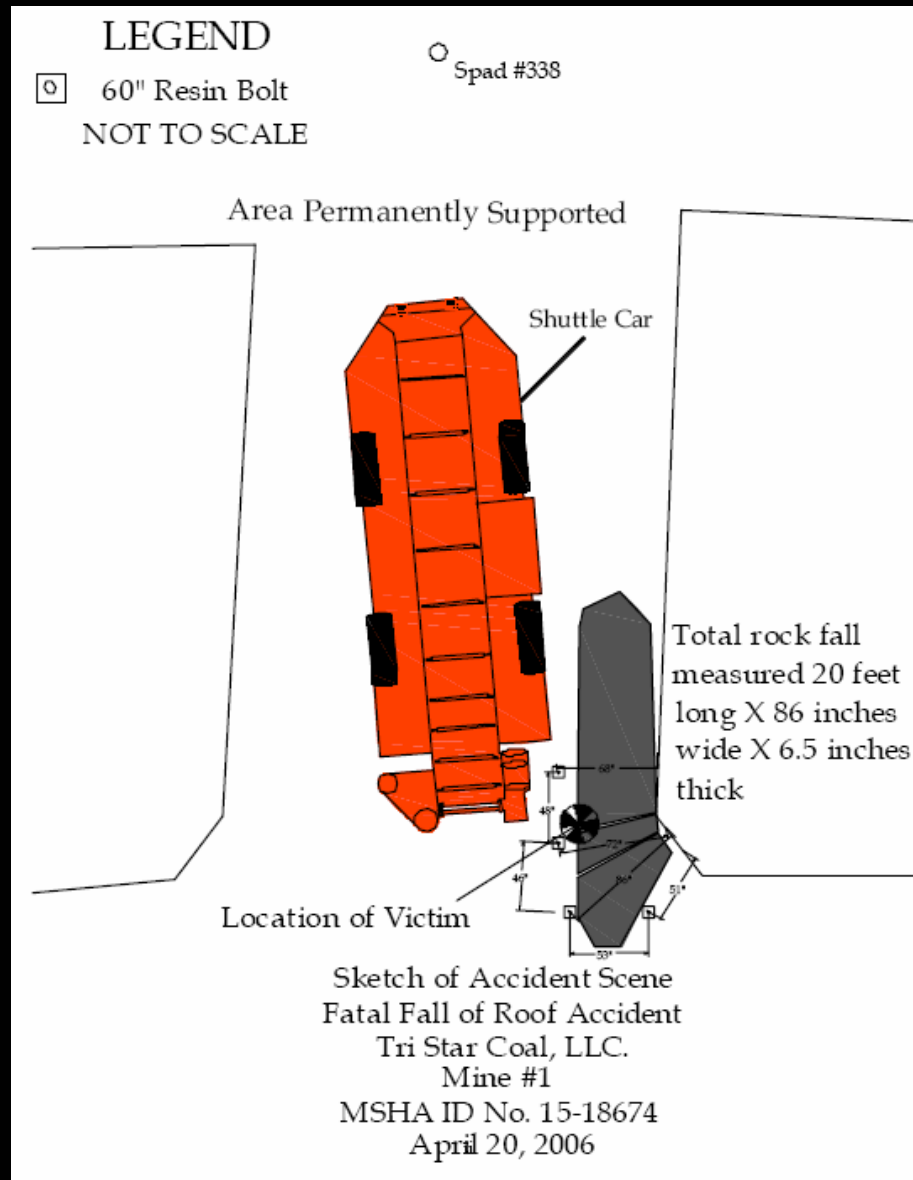
On April 20, 2006, a 28-year-old shuttle car operator, was fatally injured in a roof fall accident on the 002-0 MMU Section.

The accident occurred as the victim was returning to his shuttle car after moving the cable anchor location and scouting his route of travel to the continuous mining machine. A section of roof rock measuring approximately 20 feet by 86 inches by 6.5 inches thick fell from between the roof bolts and the coal rib. The rock struck him pinning him against the mine floor, causing fatal crushing injuries.
